**Report No. UT-04.03**

# **Annual Experimental Features Report**

***Utah Department of Transportation Research  
Division***

***June 2004***

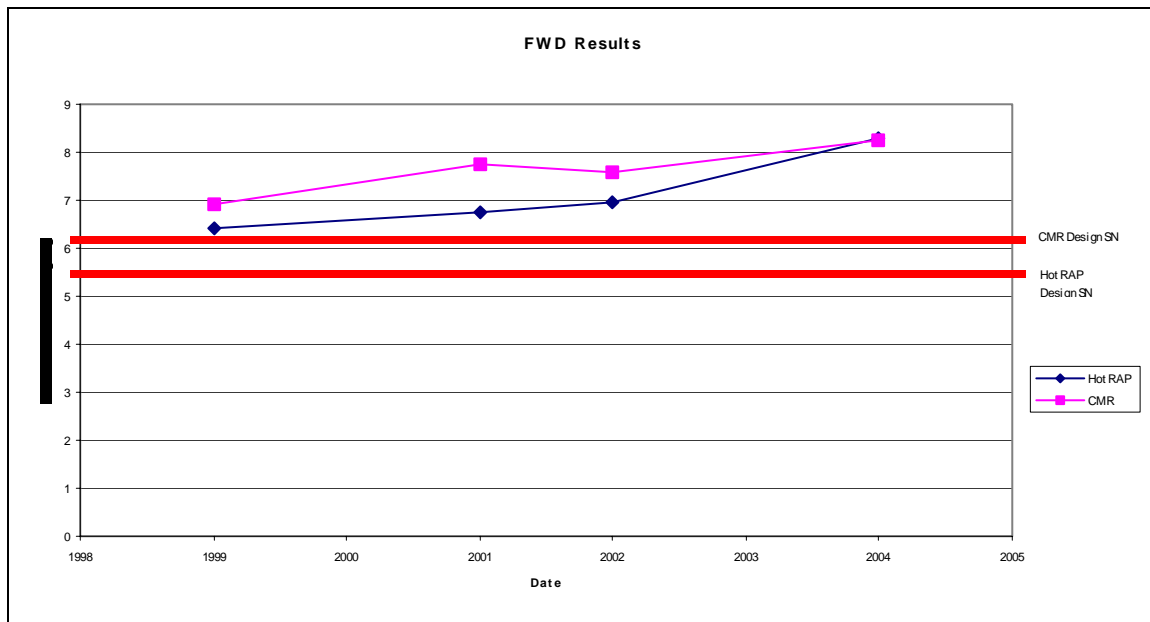
The Program Development unit has taken FWD structural readings for 1999, 2001, 2002, and 2004. The results are presented in the following table with the design SN included for reference.

It is clear both designs are performing better than designed.

Based upon the interim evaluations for structural strengths (FWD), UDOT Research recommends either section strategy is viable depending on circumstances. The most important factor to consider is the structure of the pavement section. CMR should only be considered as an option where the structure of the pavement is still good and the asphalt surface is deteriorated (i.e. thermal cracking, oxidation, weathering, etc.) CMR should not be considered where fatigue cracking or rutting (structure-related) are the cause of pavement failure.

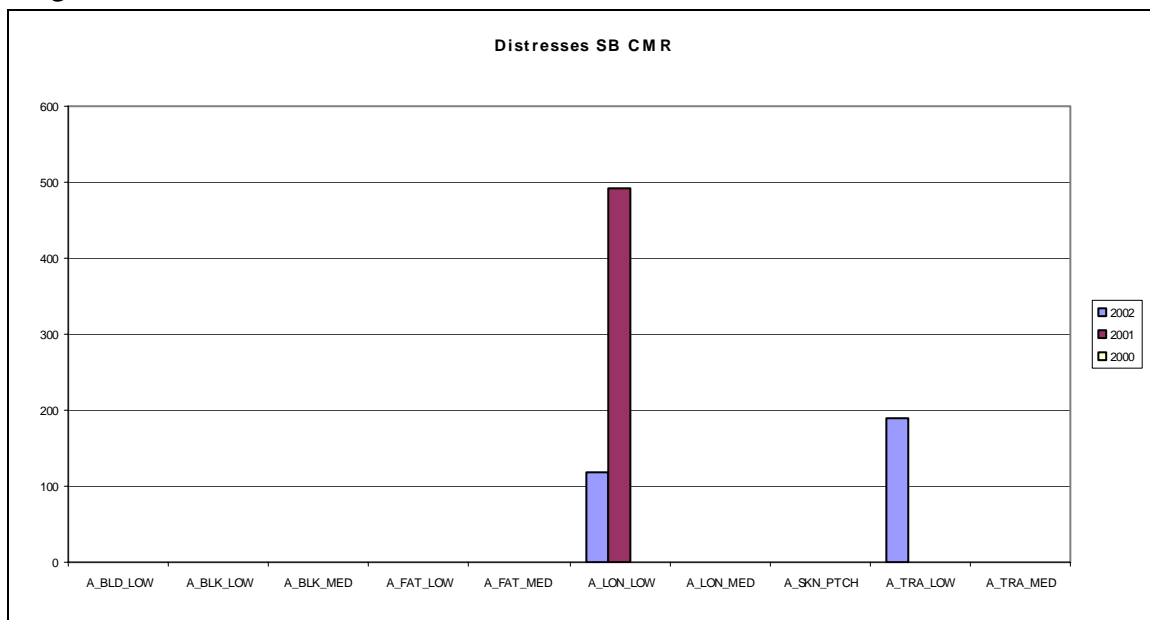
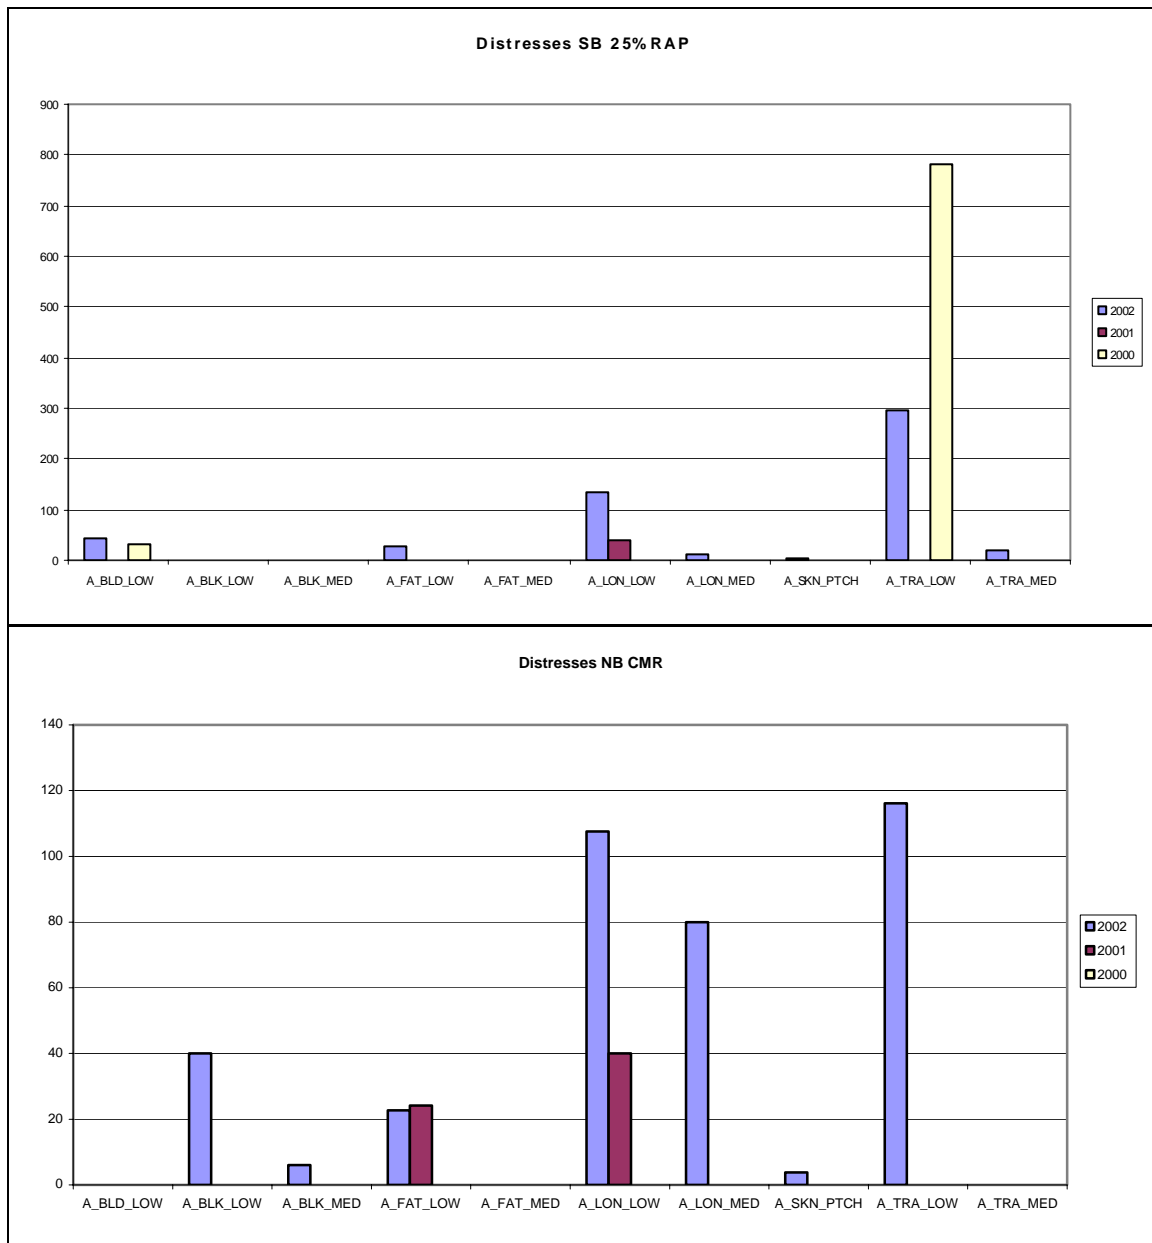
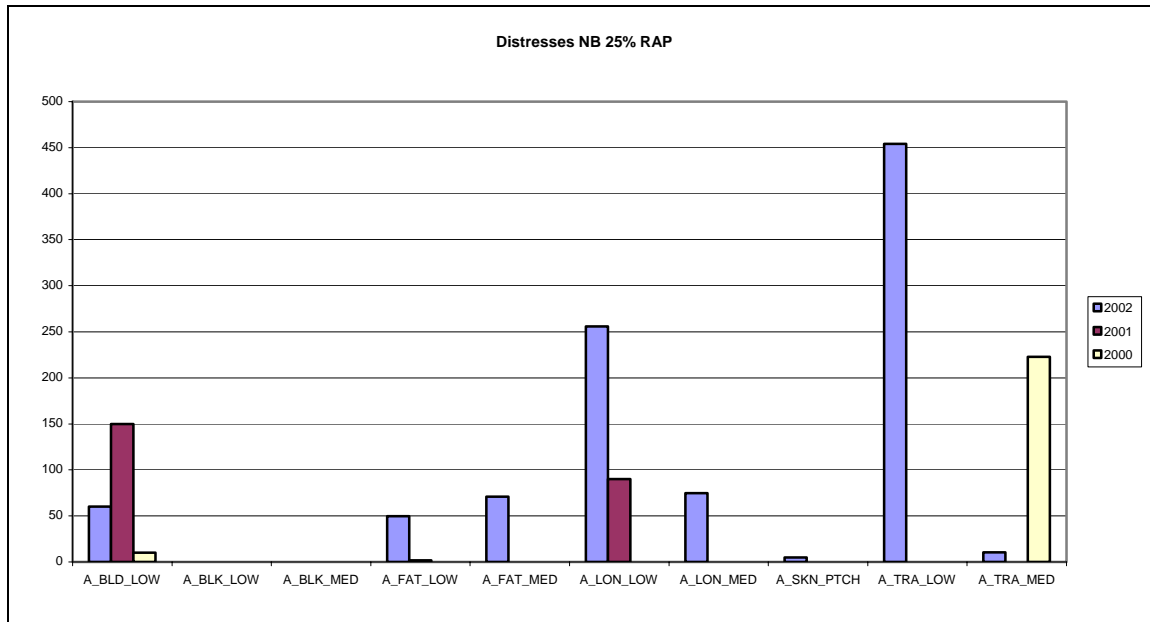
The PCI inspections show the material is beginning to show fatigue and thermal cracking. However, there doesn't seem to be a difference between the two strategies.

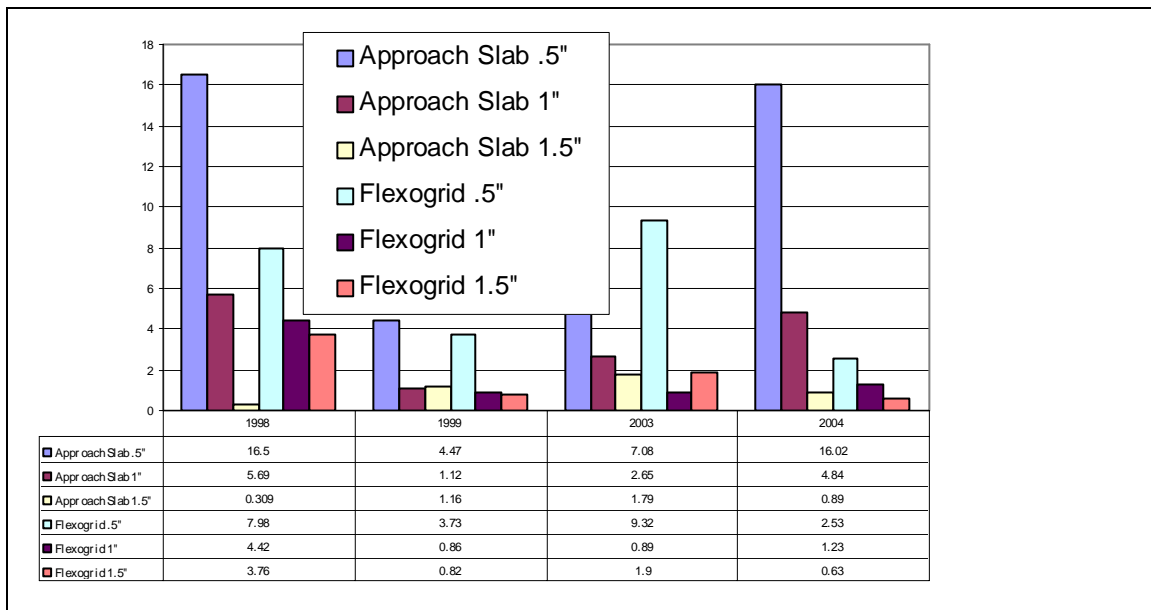
**Figure 4-Chloride Content Test Results**

Figure 4 shows the results of the first five years of chloride content results. The key number is the 1 ½" depth. As long as it is below 3 pounds per cubic yard corrosion is unlikely to occur and the rebar depth is at least 2".

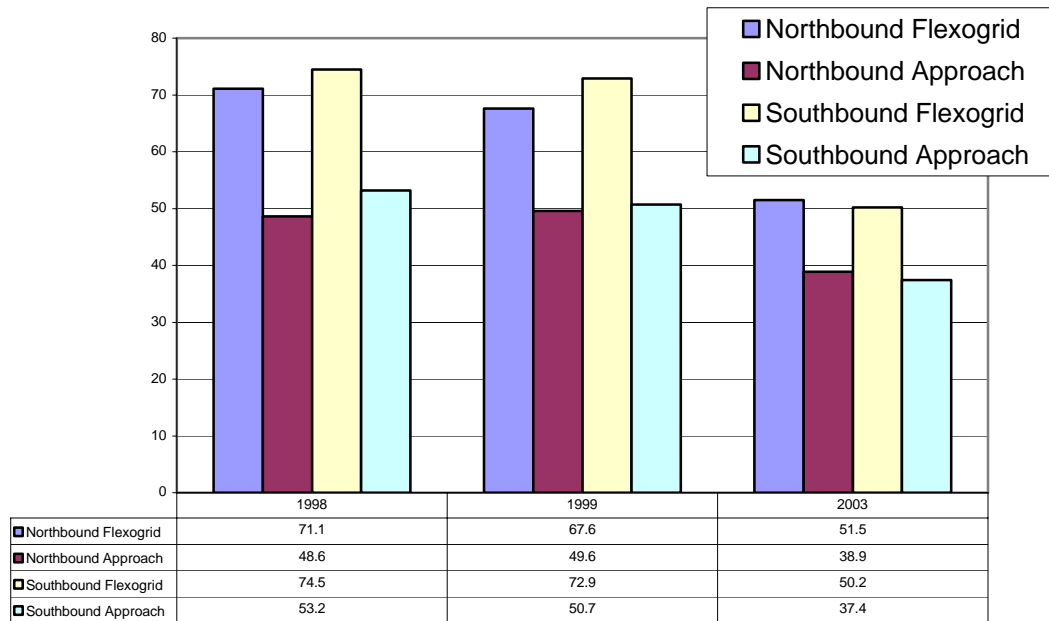
**Figure 5-Skid Resistance Test**

Figure 5 shows the results from the first five years of skid resistance. Numbers above 45 are considered moderate to UDOT.

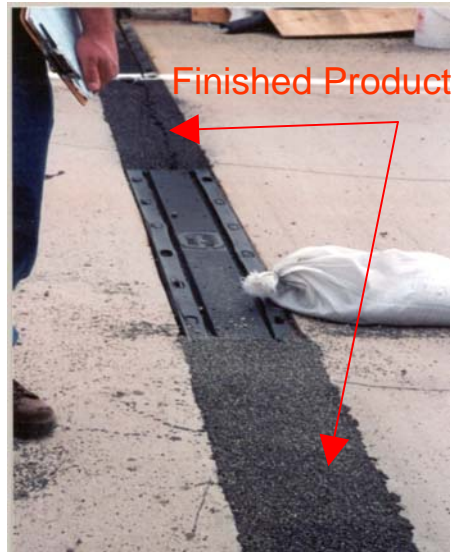
Figure 11-Finished product

The product was placed in April 2001. Research visited the test site on September 2, 2002. The condition of the experimental material was good. The material showed slight signs of cracking and spalling. However, the concrete adjacent to the product was beginning to spall (See Appendix).

The opinion of UDOT Research is that the expansion of the bridge deck had transferred through the product and caused the concrete on either side of the product to fail in compression. It appeared as though the compressive strength of the product exceeded that of the concrete. The Structures Division Inspectors rated the condition of the bridge deck as “satisfactory” on an excellent to poor scale (the condition of the bridge deck was “bad” in the opinion of the evaluators). This may have contributed to the spalling in the concrete.

Ure-Fast PF-60 should not be used in the future to replace expansion joints on bridges that have at least as much expansion as this bridge. The material may work alone in another location where the bridge does not expand as much as this bridge.

Ure-Fast PF-60 can and should be used with the Ure-Fast liquid sealant to replace the joint (See Appendix). Other states have had success with this combination.

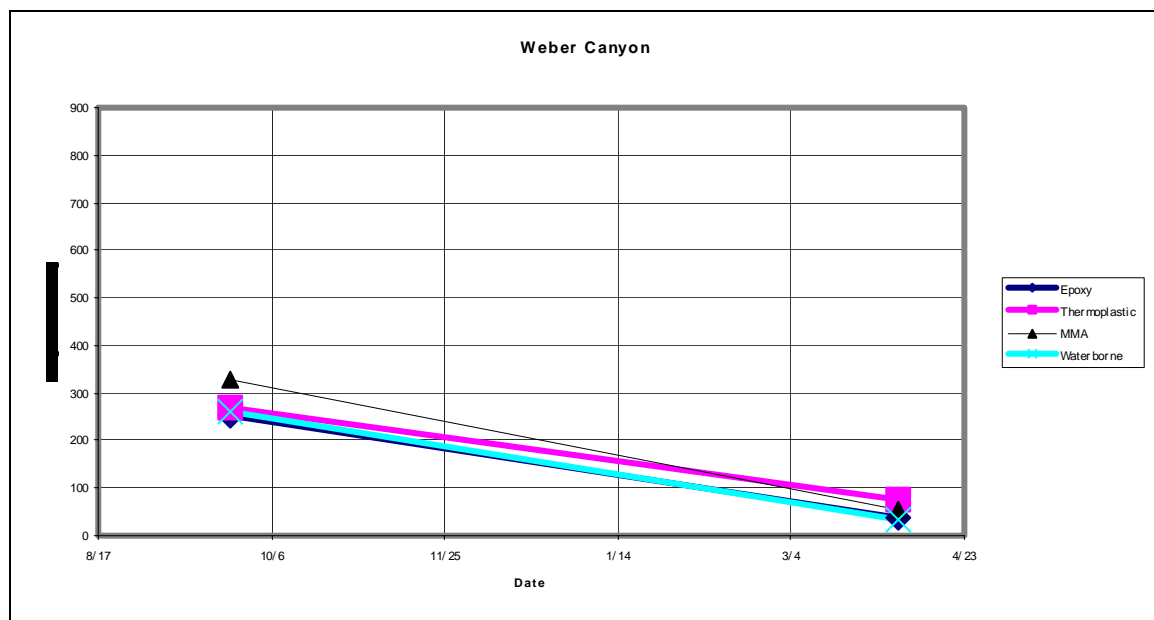
1. Retro-reflectivity: All products failed (below 100) after 1 plow season.

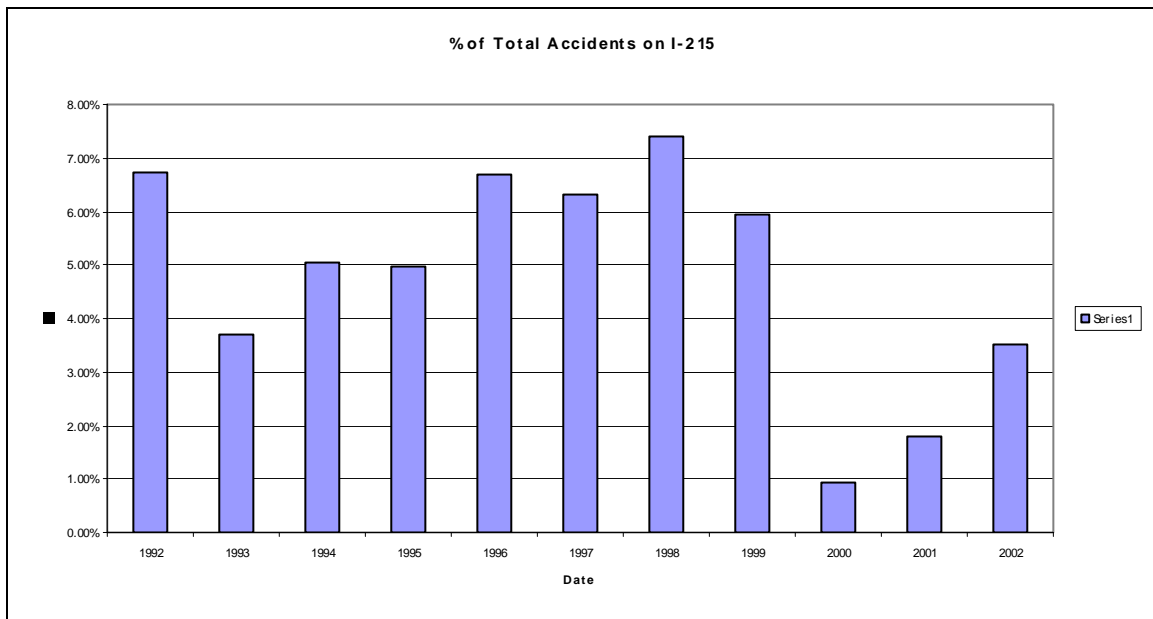
This graph basically sets a baseline, since 2003 data hasn't yet been processed and it is the only year where the system has been fully automated. It is interesting to note that the polymer overlay was placed in 2000 (in conjunction

with half the system) and that appears to be the year with the fewest % of crashes.

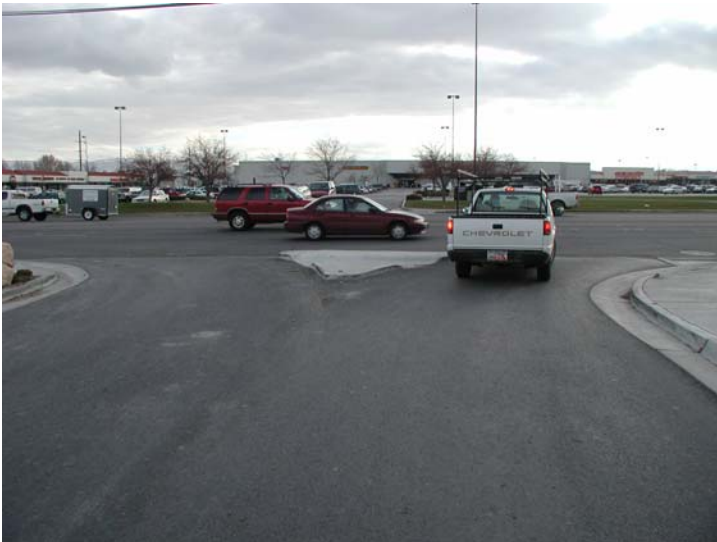
The following figure shows the pork chop as seen by an exiting driver.

Although hard to see from this picture, there used to be a no-left-turn sign on this location, but was not present during this study.

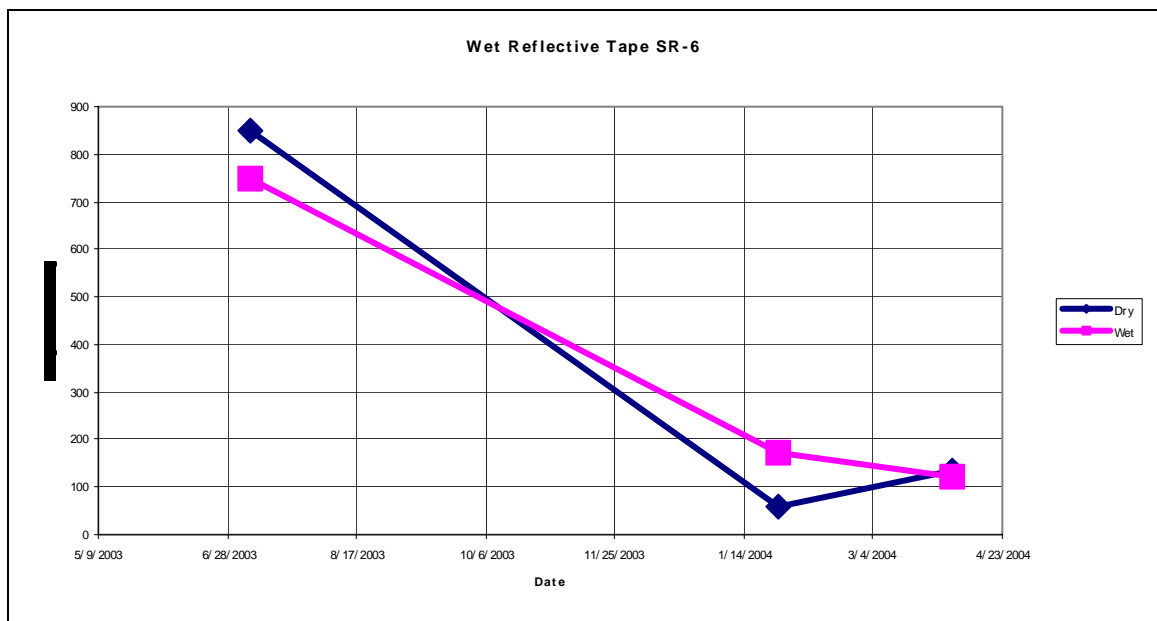
1. The initial retro reflectivity was very good. However, there was a large standard deviation in the data. The data shows a dramatic decline in the RR over the first season. The wet-night retroreflectivity was measured using the LTL 2000 and showed good results.

The chart shows the dramatic decline. Interestingly, the values doubled or sometimes tripled if the RR was measured against the flow of traffic. This hasn't been explained, but may indicate the product is more sensitive to snow plow abrasion than other markings.

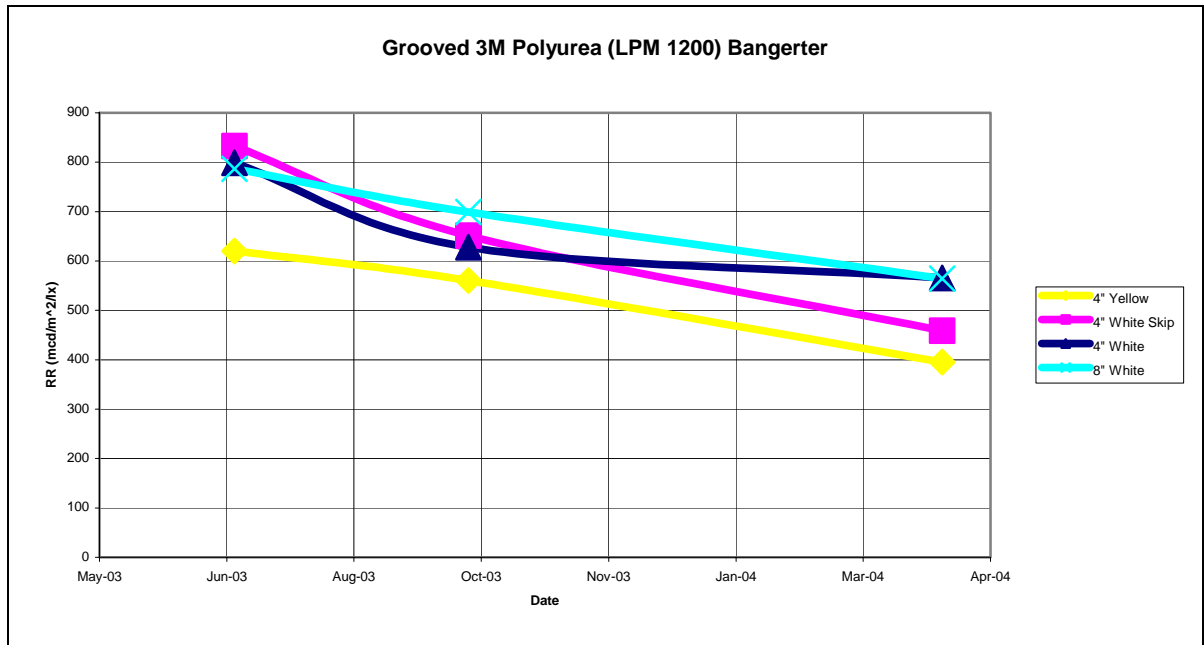
4" Yellow			4" White Skip		
	Jul-03	Oct-03	Apr-04	Jul-03	Oct-03	Apr-04
Mean	678	572	423	899	661	440
Standard Deviation	118	83	158	100	77	165
Allowable Error =>	29	20	40	18	13	29

4" White			8" White		
Jul-03	Oct-03	Apr-04	Jul-03	Oct-03	Apr-04
830	597	516	767	660	472
143	102	149	123	105	183
36	25	37	47	34	60

This material appears to be susceptible to snowplow damage. For future applications, the inlay depth should be monitored closely to ensure the snowplow blades will not come into contact with the material. Also, the contractor should use an inlay grinder that gives a smooth depth and surface when complete.

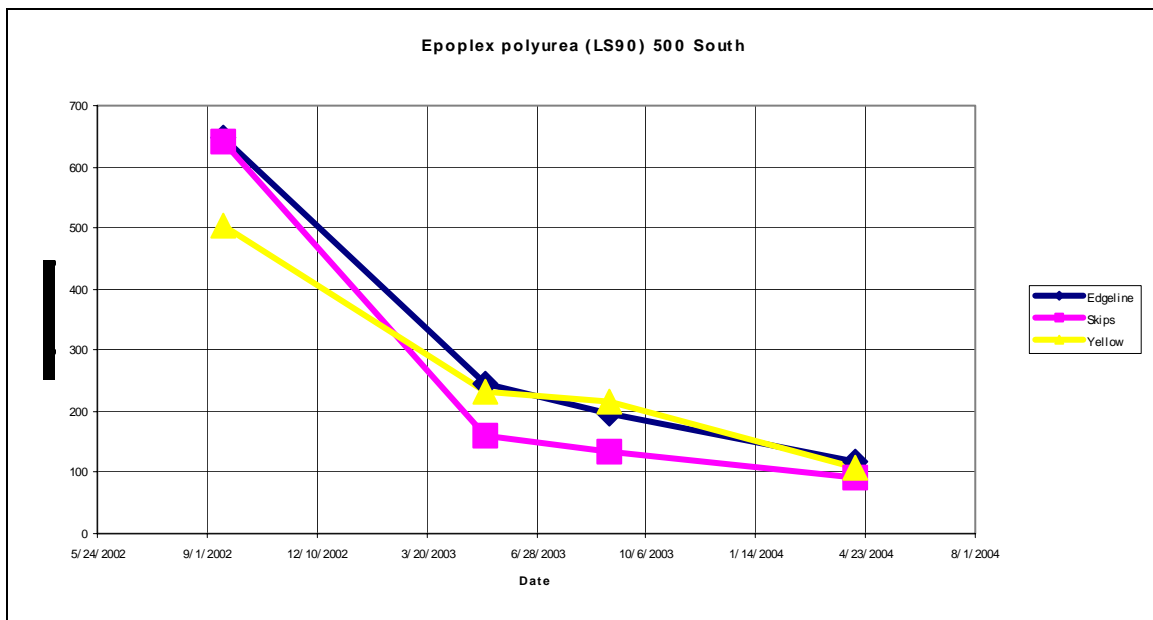
1. Two snowplow seasons yielded the following retro-reflectivity results:

<b>9/16/2002</b>	<b>5/13/2003</b>	<b>9/2/2003</b>	<b>4/14/2004</b>
<b>Edgeline</b>	647	246	197	116
<b>Skips</b>	642	161	133	92
<b>Yellow</b>	503	231	215	107

The material has shown excessive wear, especially on the skip lines. However, at this location, the material has performed well. The material is at UDOT's trigger value for re-striping.

This material has shown its ability to provide good durability at a location where conditions for pavement markings are severe. UDOT should use this product in severe applications. The cost of the material is prohibitive, but may be cost-effective in severe conditions.

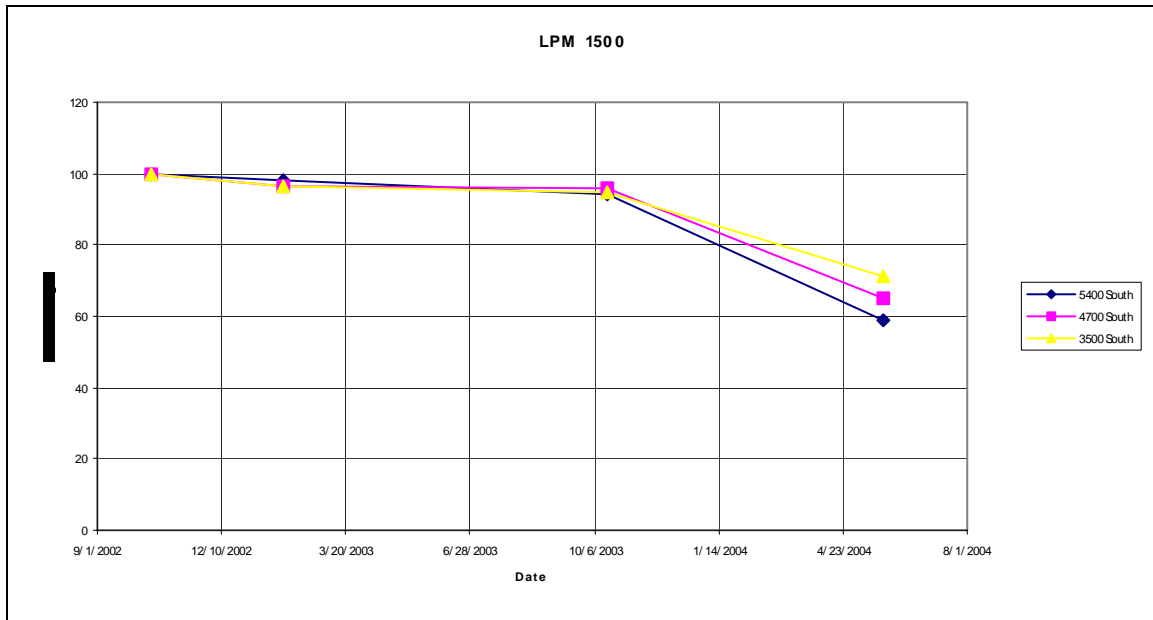
1. Two plow seasons yielded the following results:

The material has performed well for the given conditions. The AADT for this area is about 50,000 and these areas experience a lot of wear from braking and acceleration. The price is a high, but may be justified because most other markings would probably not make it through a season.

There wasn't a control set up on this project. It is recommended that this product be installed next to the product that would typically be used for these locations. This is the only way to determine whether or not this product is more cost-effective than the current practice.

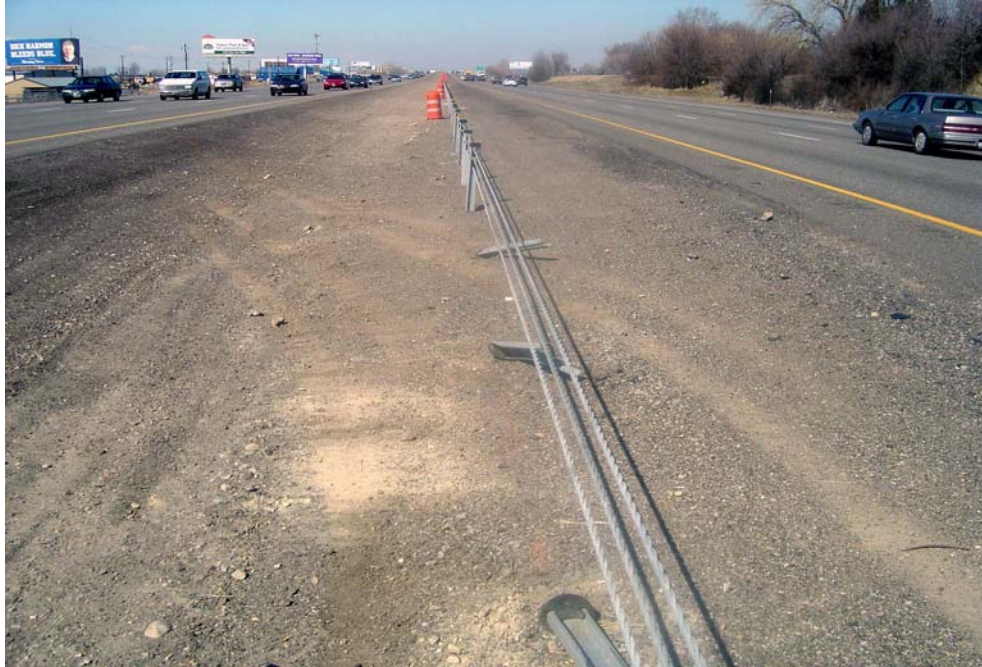
These systems have proven to be effective in preventing crossover fatalities. The picture below shows tire tracks that show that if the cable barrier had not been in place, there would probably have been a collision.

UDOT should look into placing more of these systems in locations where concrete barrier is cost-prohibitive. Systems that are installed should have pre-stressed cables. Non-stressed cable would require more maintenance due to the need to re-tension after a hit.
